## Summary

## Maintenance & Upgrade

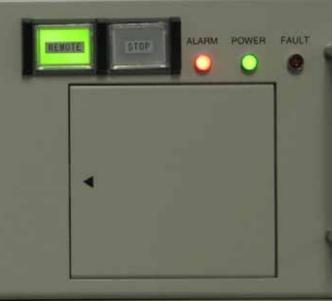
#### **TCFRCU**

## Upgraded FRCU

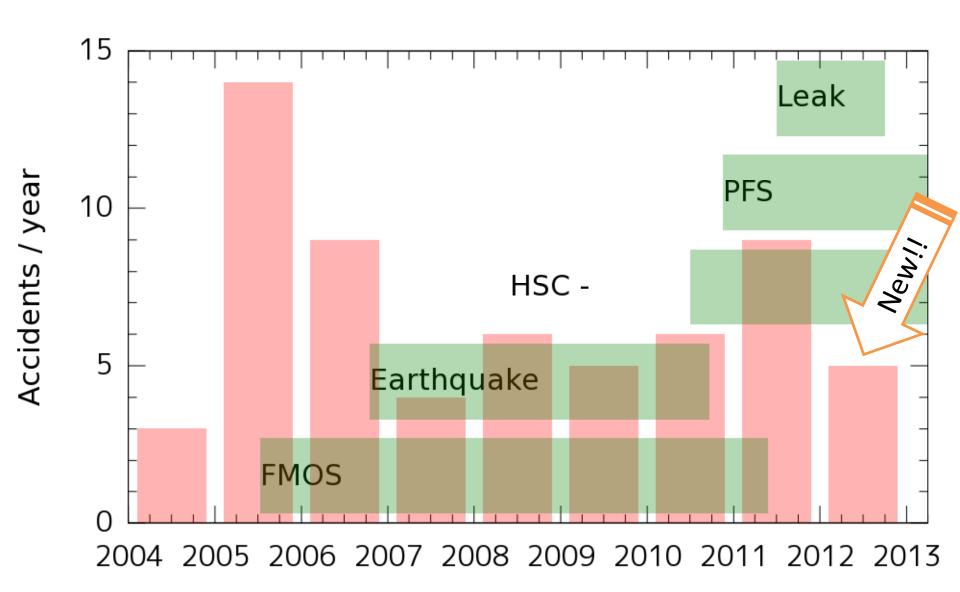
### **Troubles**
